# 2018 Data Report for Stony Lake, Oceana County

Site ID: 640049

# Stony Lake, Oceana County 2018 CLMP Results

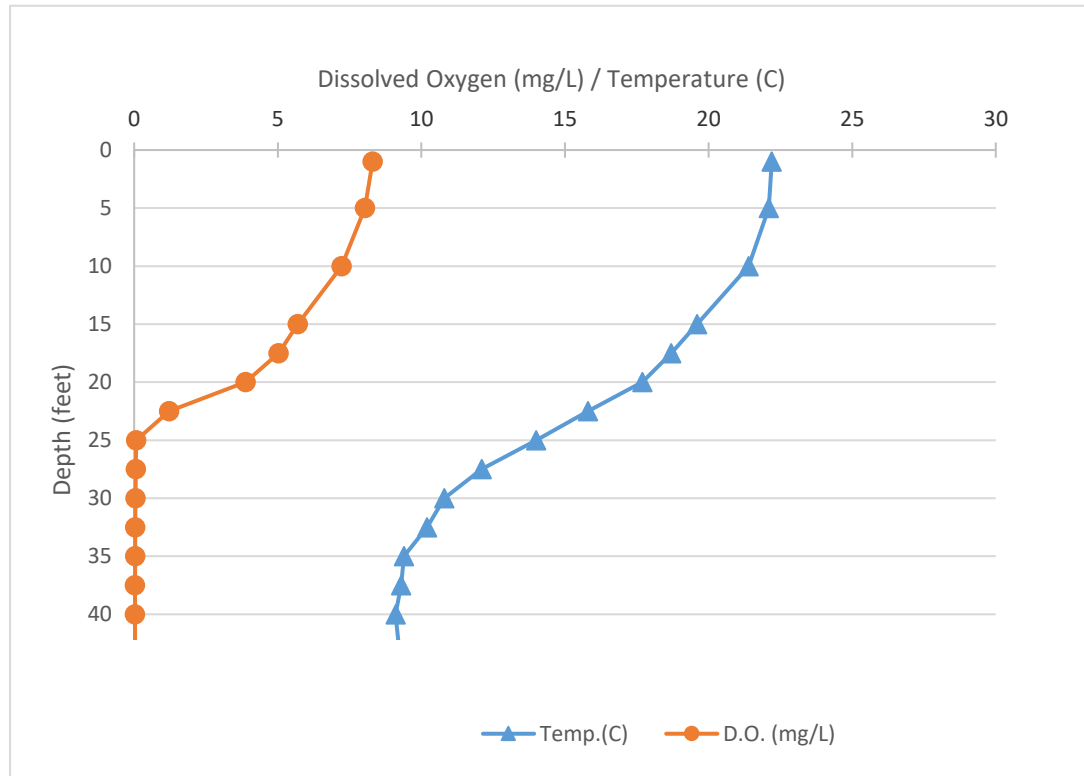
8/31/2018

Depth (ft)	Temp.(C)	D.O. (mg/L)
1	22.2	8.3
5	22.1	8.04
10	21.4	7.22
15	19.6	5.7
17.5	18.7	5.03
20	17.7	3.88
22.5	15.8	1.22
25	14	0.07
27.5	12.1	0.06
30	10.8	0.05
32.5	10.2	0.04
35	9.4	0.04
37.5	9.3	0.03
40	9.1	0.03
42.5	9.2	0.03
