2022 Data Report for Stony Lake, Oceana County

Site ID: 640049

Stony Lake, Oceana County 2022 CLMP Results

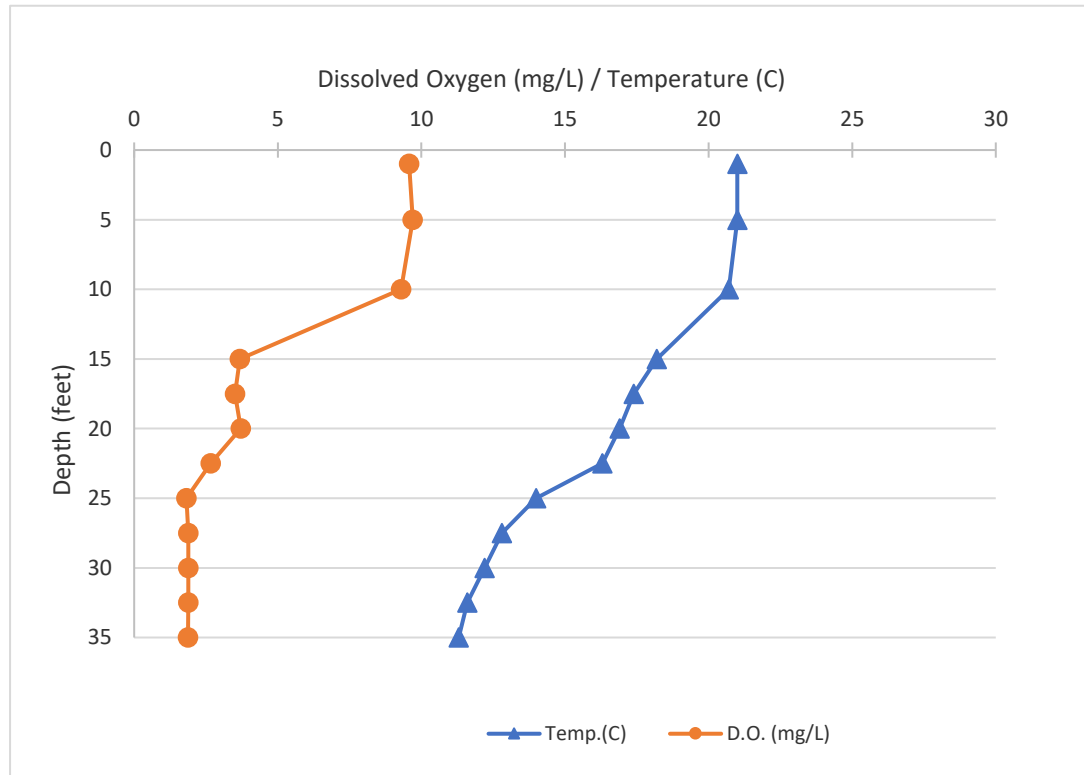
9/15/2022

Depth (ft)	Temp.(C)	D.O. (mg/L)
1	21	9.57
5	21	9.7
10	20.7	9.3
15	18.2	3.68
17.5	17.4	3.51
20	16.9	3.71
22.5	16.3	2.66
25	14	1.82
27.5	12.8	1.88
30	12.2	1.89
32.5	11.6	1.89
35	11.3	1.87

This lake stratifies in mid-summer and remains stratified into early fall. The data indicate that despite stratification, this lake maintains some oxygen in the bottoms waters throughout the monitoring season.
